MINING
ELECTRICAL
SAFETY 2017
CONFERENCE

High Voltage Trucks

Protection and Fire Prevention

Case Study Truck Fire

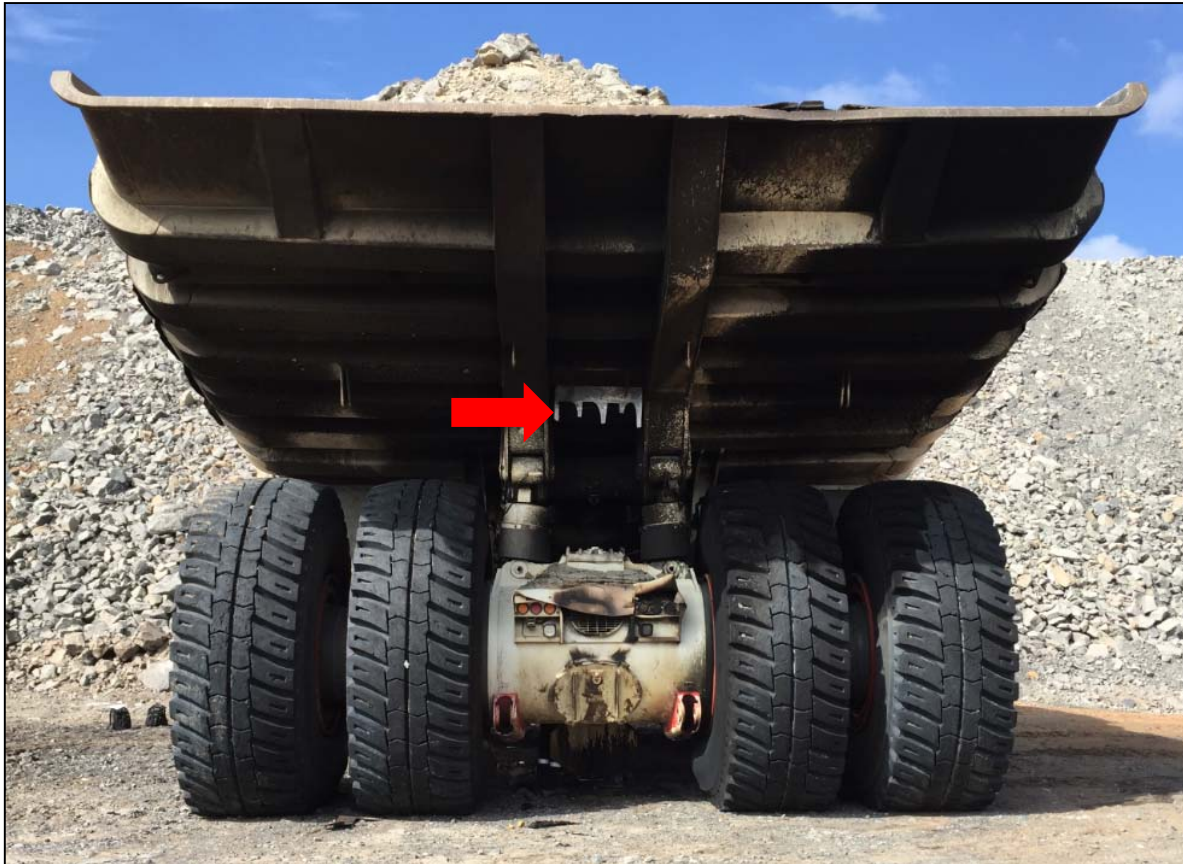
Truck travelling to the dump, dozer operator reported the fire to the truck operator.

Note: The aluminum truck ID sign has melted. (~530 C)

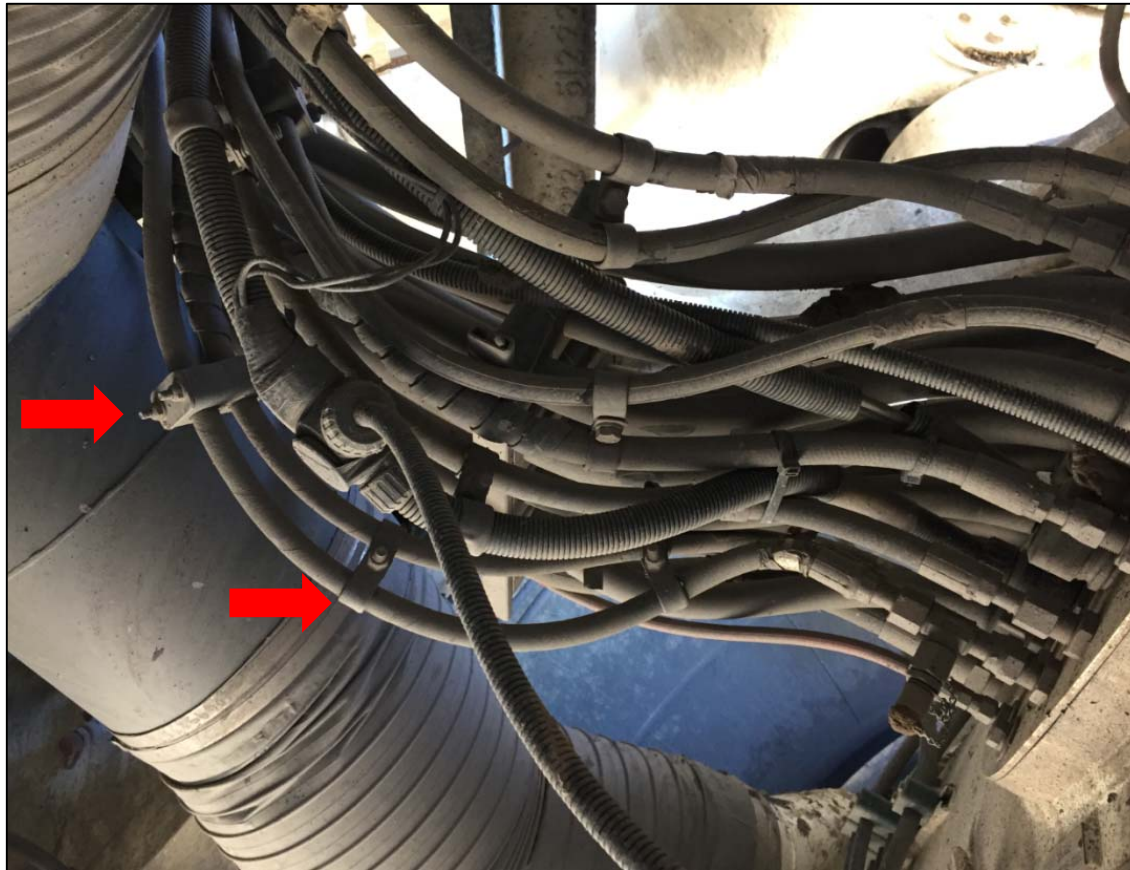
The affected area should look like this

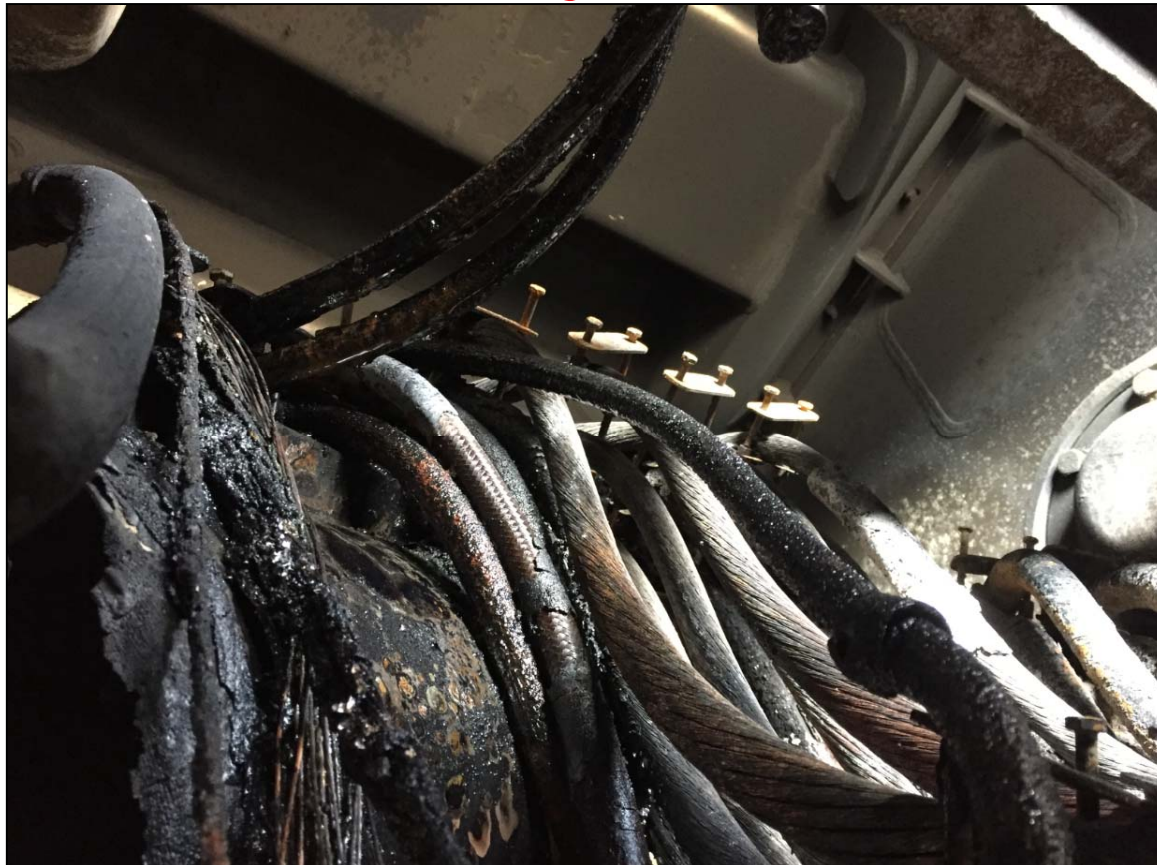
Close up view of the High Voltage harness and hydraulic lines

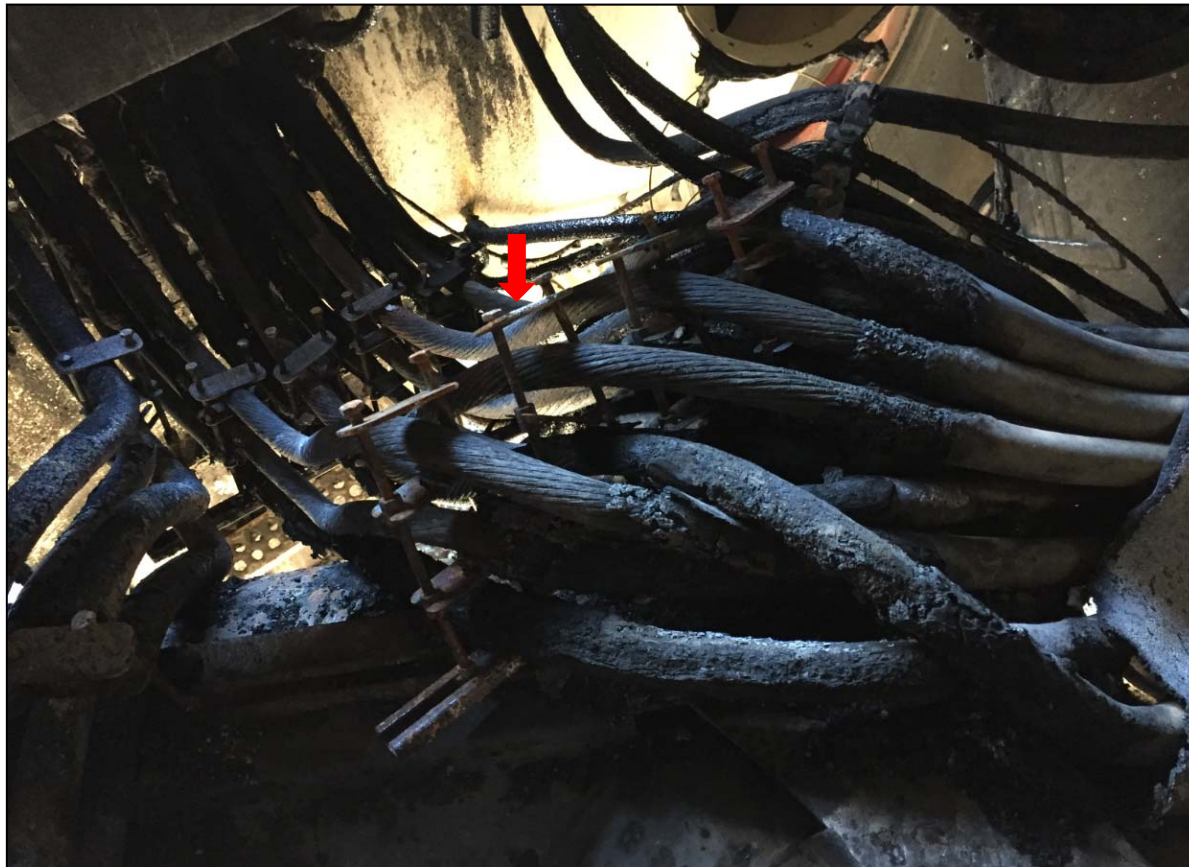
View looking down on the High Voltage harness and hydraulic lines

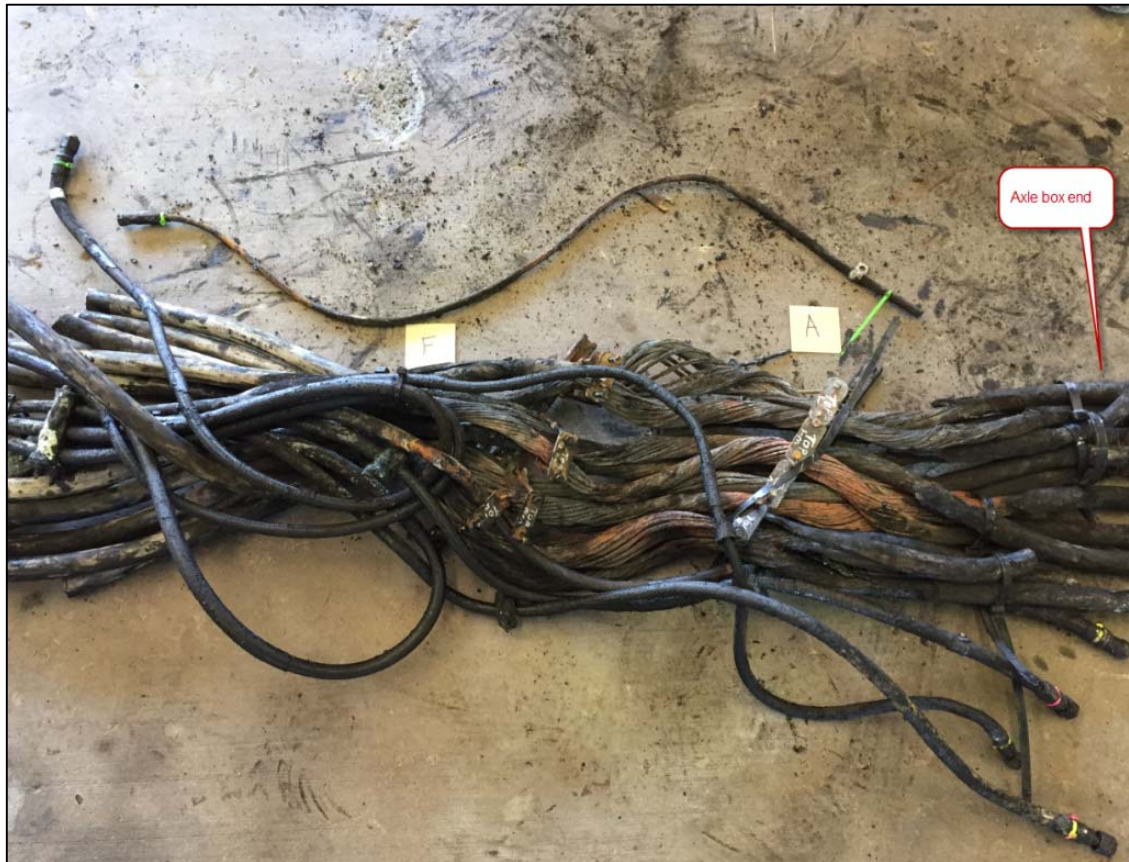
High Voltage harness
and hydraulic lines
removed and inspected

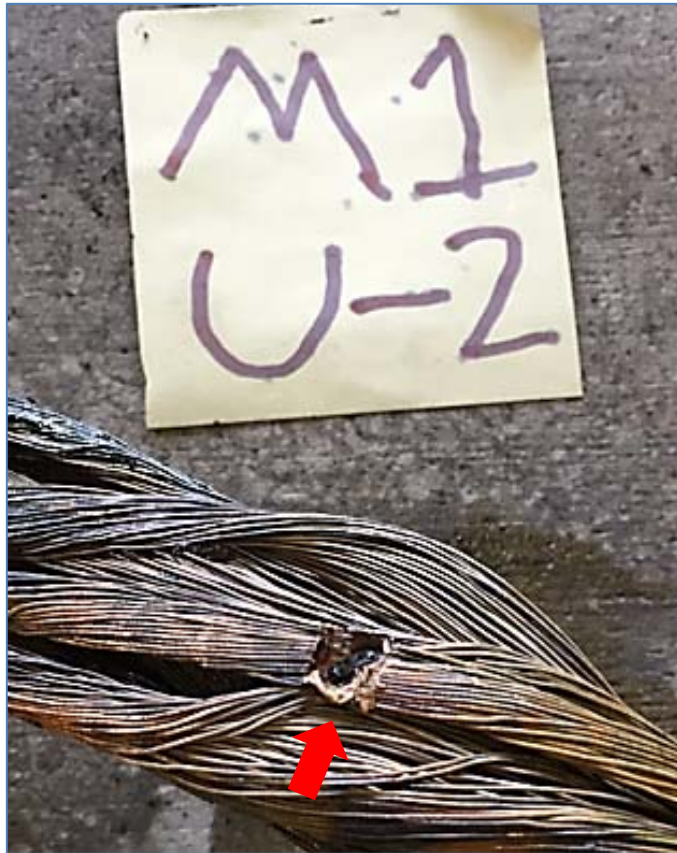
Identified cable arcing
on Motor 1 Phase U-2

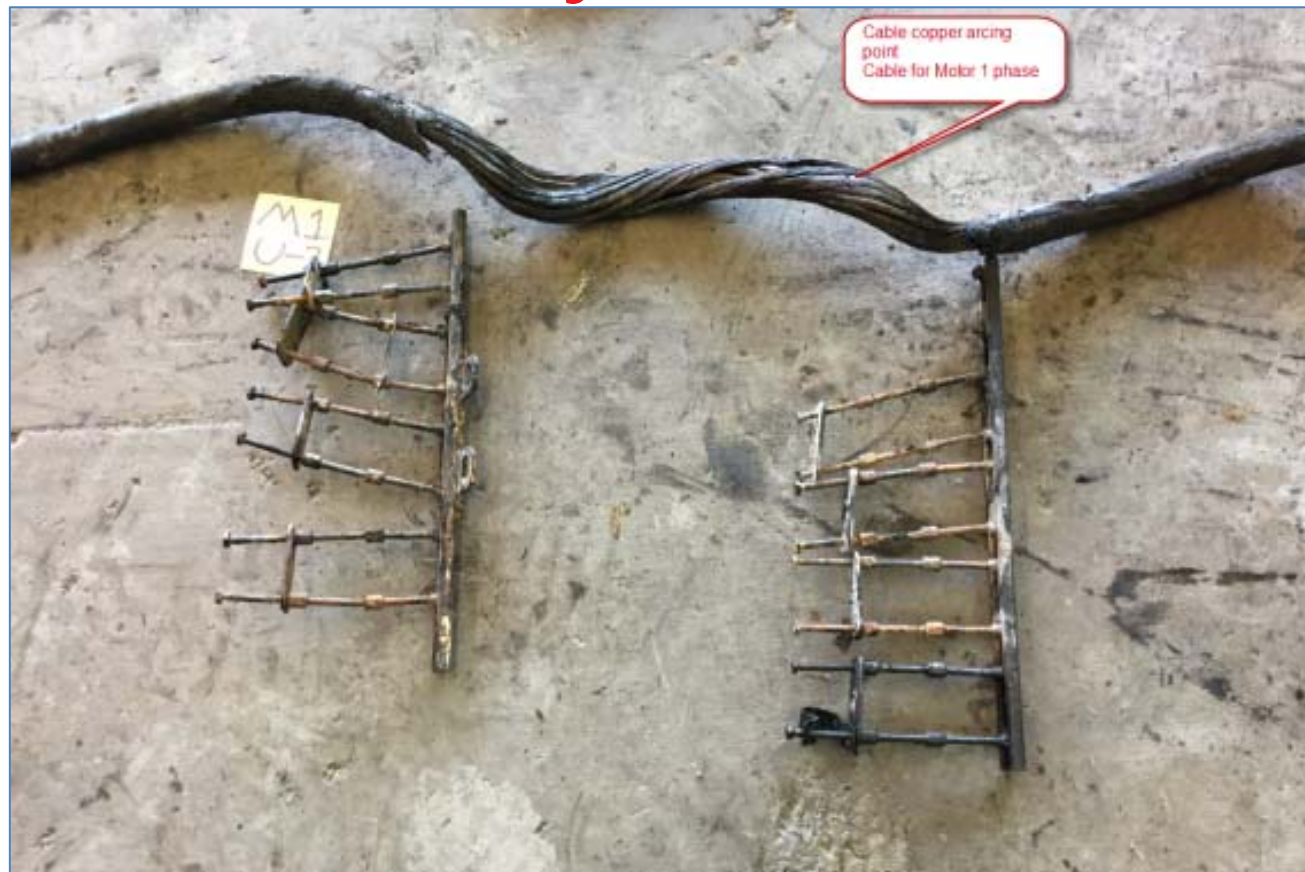
Identified cable arcing on Motor 1 Phase U-2.

This position was in mid air between the major Stauff support clamps.

From the evidence of the arcing damage, there was current flow between Motor 1 U - 2 and most probably U -1 phase. The drive system wouldn't protect easily for this type of fault. Trip 3,800 A for 0.5 seconds.

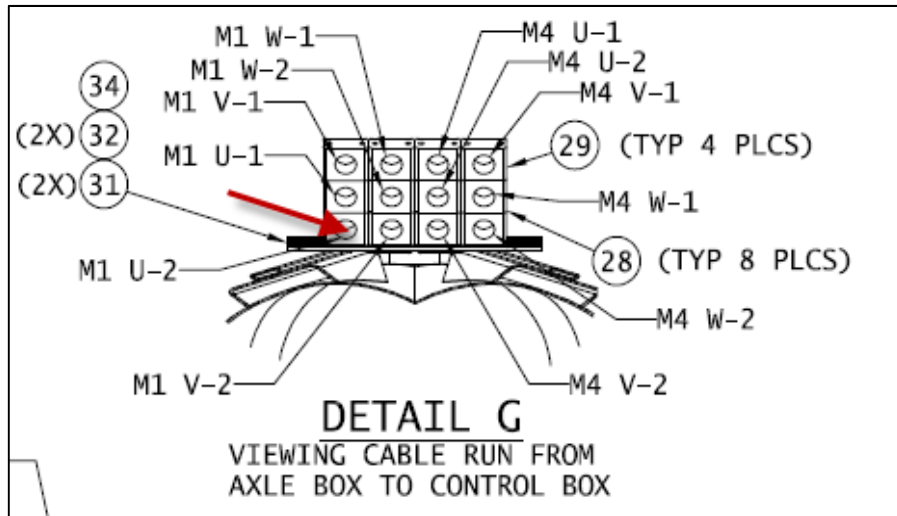
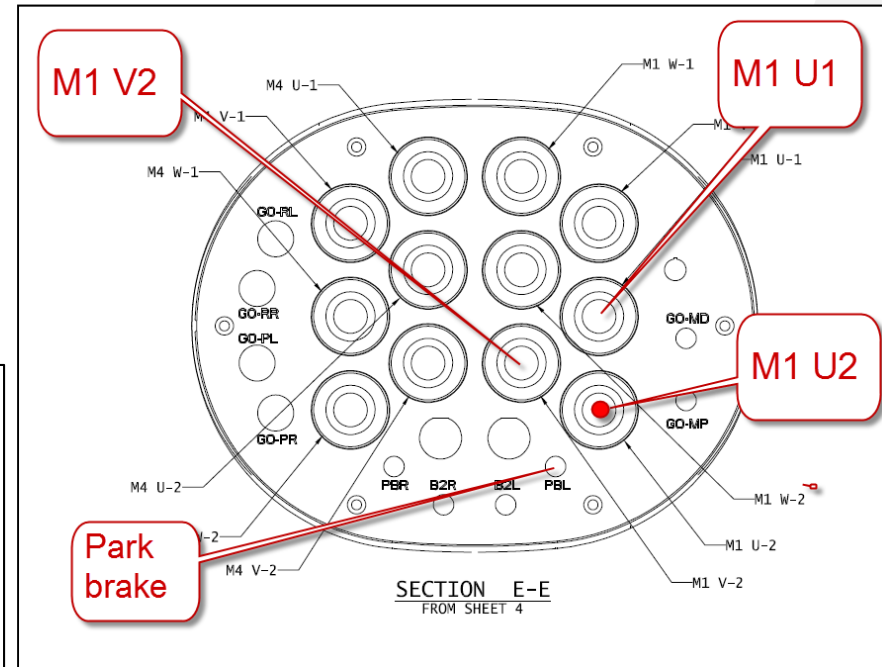
Identified cable arcing on Motor 1 Phase U-2

Melting temperature for copper is 1,082C
Cable 535.3MCM (American). Temperature rating is 90C 2kV rated.

Stauff clamp supported the 3,400 PSI pressurised hydraulic park brake hose which eventually failed from heat accelerating the fire. Flash point of the oil 250 – 400C.

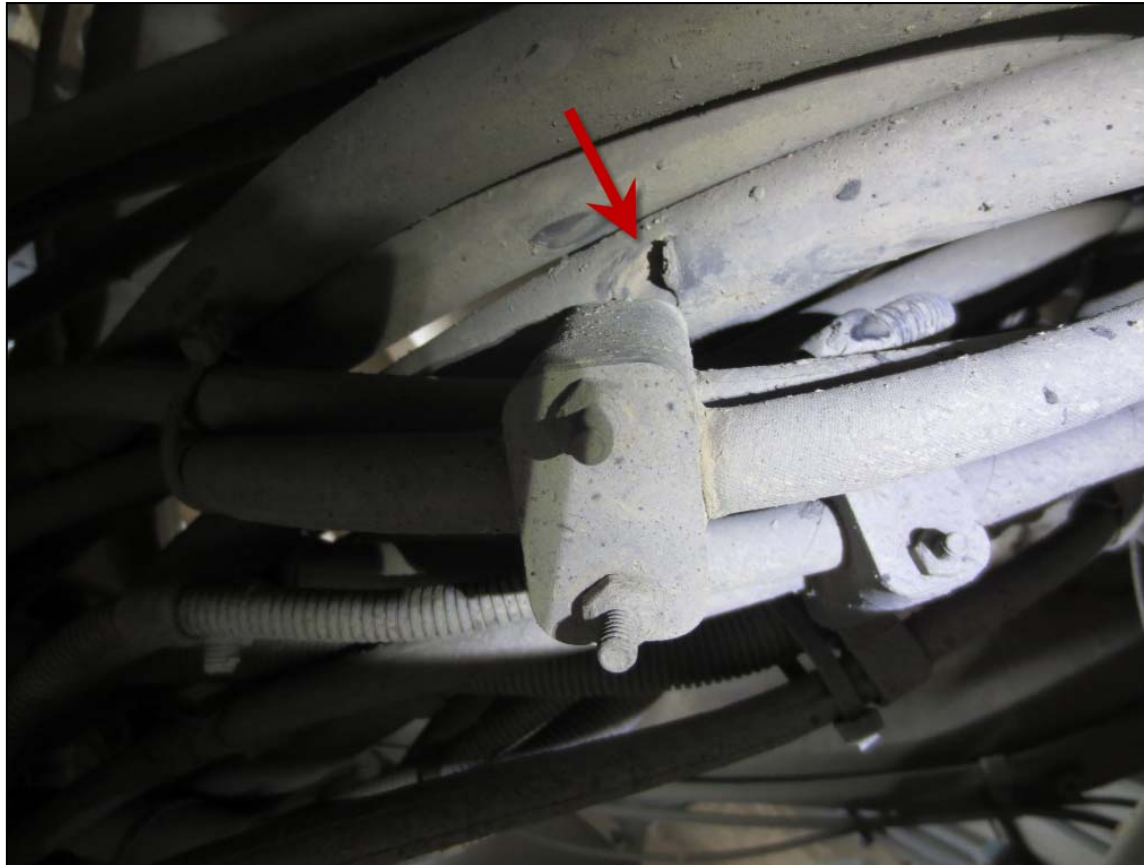
Audited truck fleets and found this cable damage

Every truck had cables and hydraulic hosing run to the axle box differently. (In Australia and the US)

There was no one common standard

- Improve cable / hose routing and standardised with the OEM

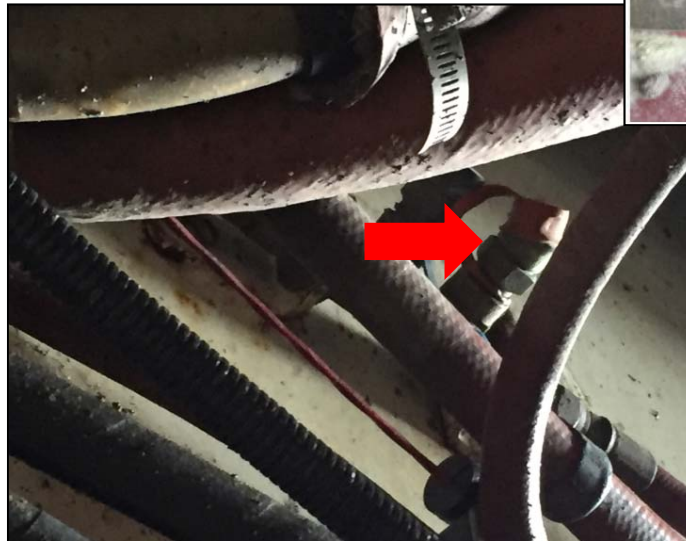
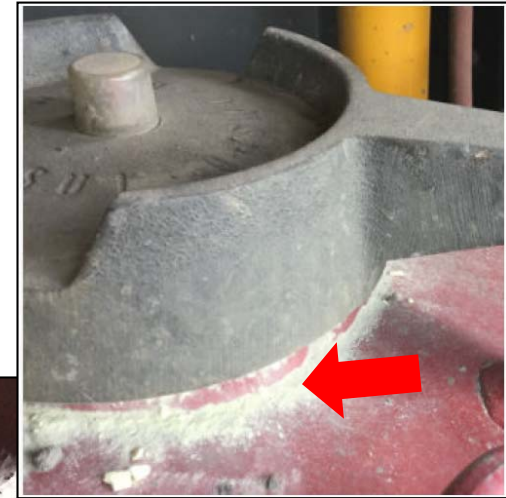
Fire suppression system failed to fully discharge all nozzles.

Filler lid was found loose on the Ansul chemical bottle. The system discharged through the fill cap on this Ansul bottle.

- Separate high pressure fluids further, a technical request sent to OEM
- Ansul fire chemical tank, installation of mechanical security to the filter cap
- Fire wire was repositioned to improve the activation time
- Education program and improvements with the inspection program, interactions between trades (Mechanical / Electrical)

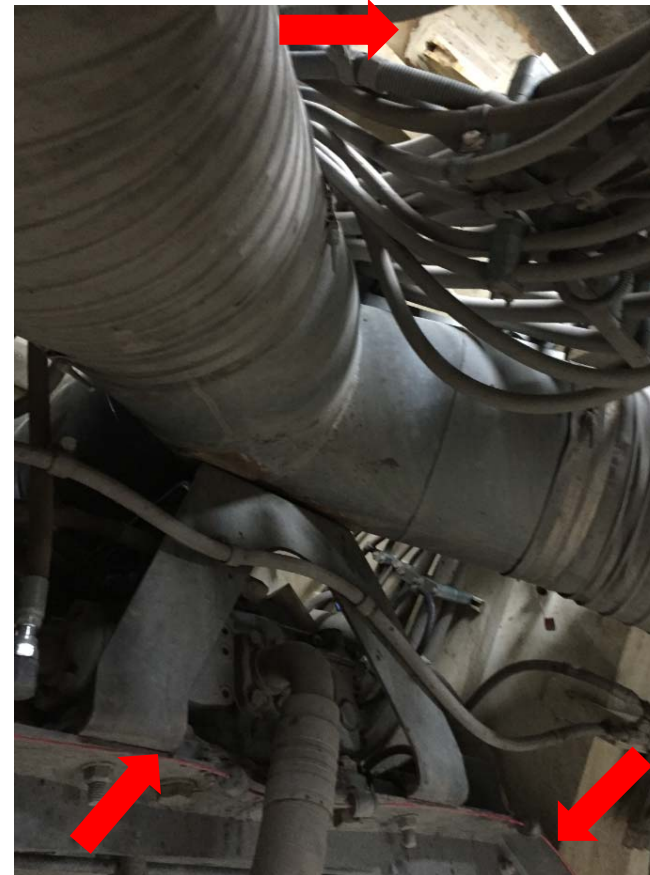
Fire wire for auto activation of the fire suppression system is located below the cable ignition risk by > 1 metre.

No heat or ignition sources below the “Y” ducting, only hydraulic pumps and hoses
