Arc Flash Incident and Hazard Mitigation & Management

Robert Lewis, General Manger Operations South SunWater Limited

Incident 2 –August 2012

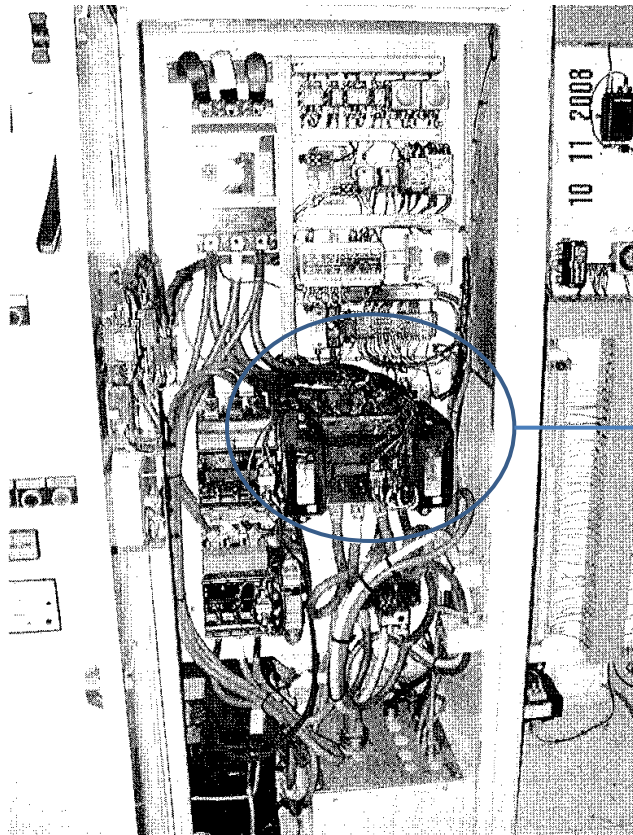
Switchboard

- A control fuse was accidentally dropped onto live terminations as it was being removed inside a motor starter panel.
- The task being performed was to test a motor protection relay.

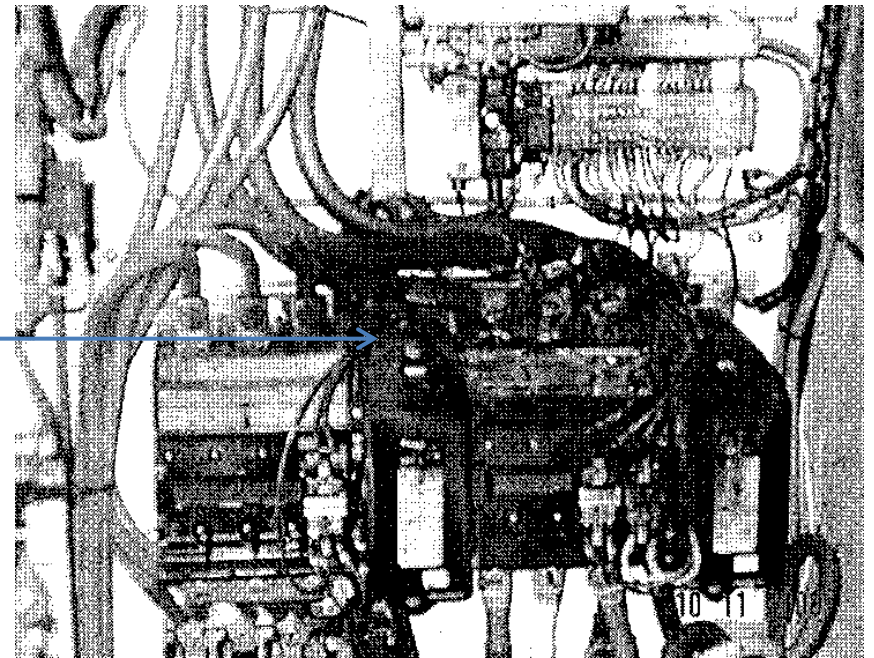
Short circuit line side contactor

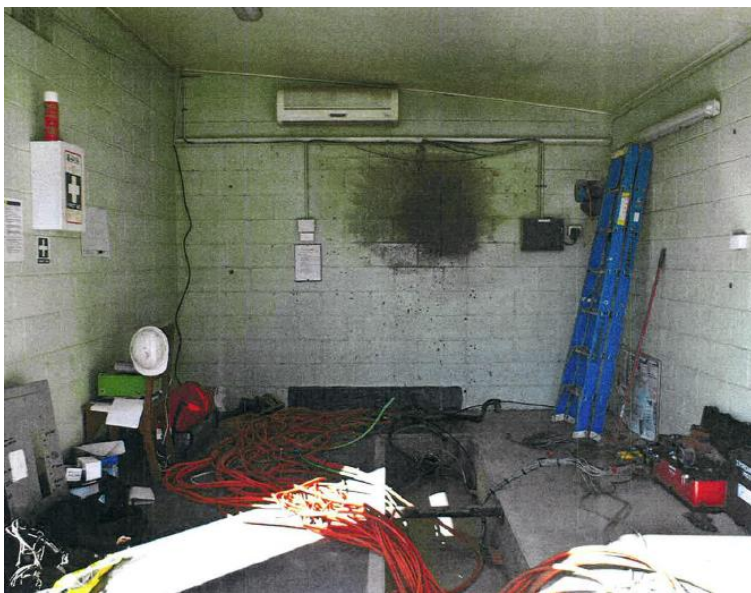
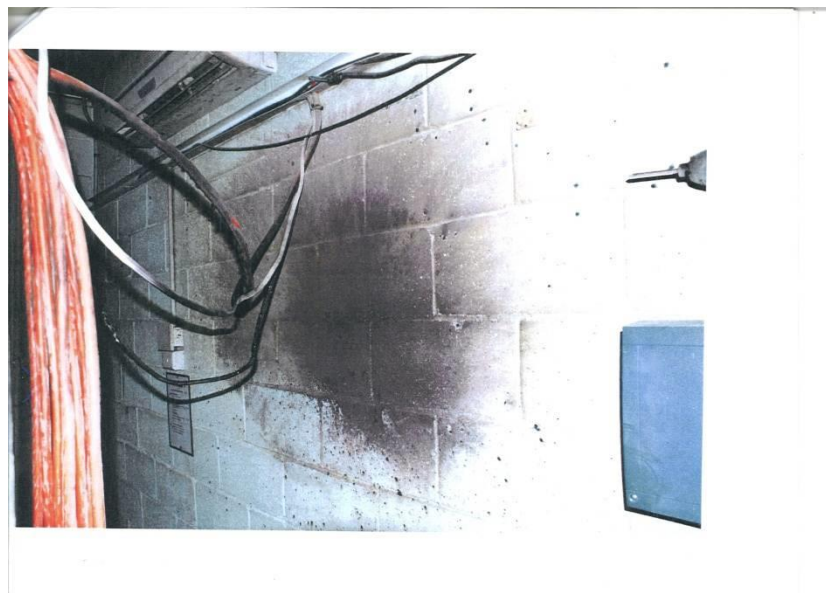
Carbon on Rear Wall Paintwork

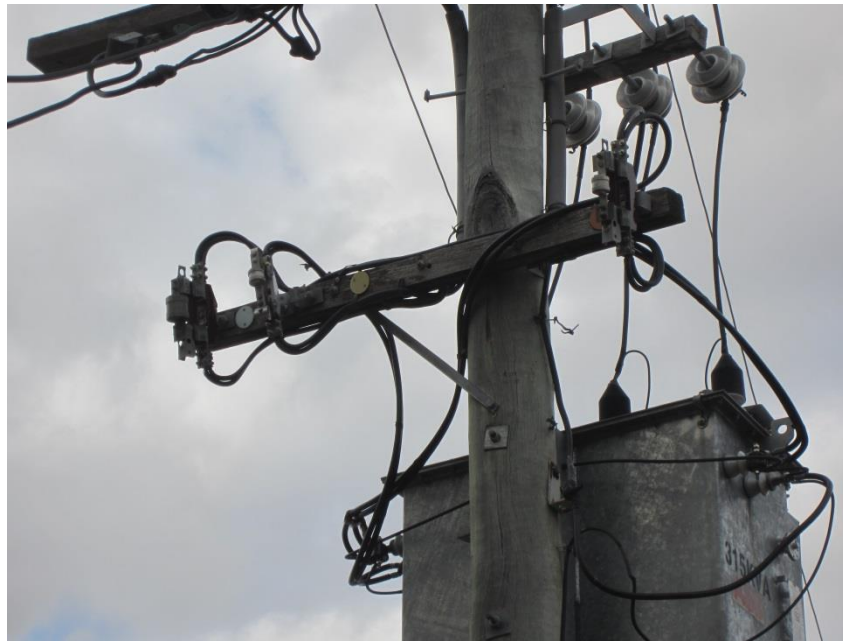
Pole top SA 500A HRC Fuses 2/3 Ruptured

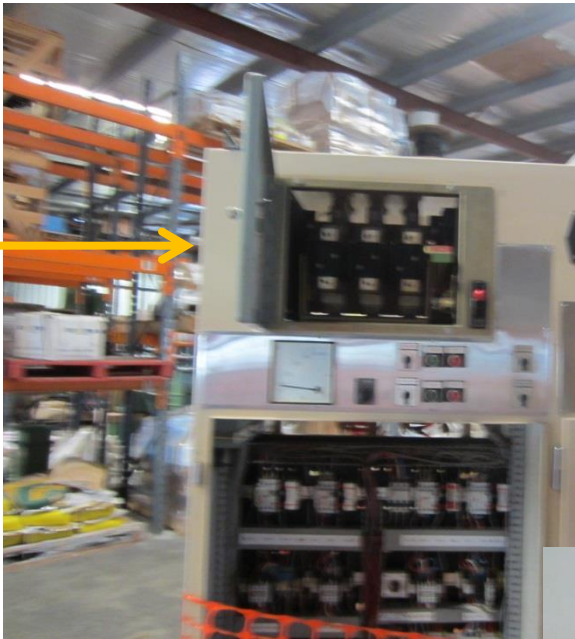
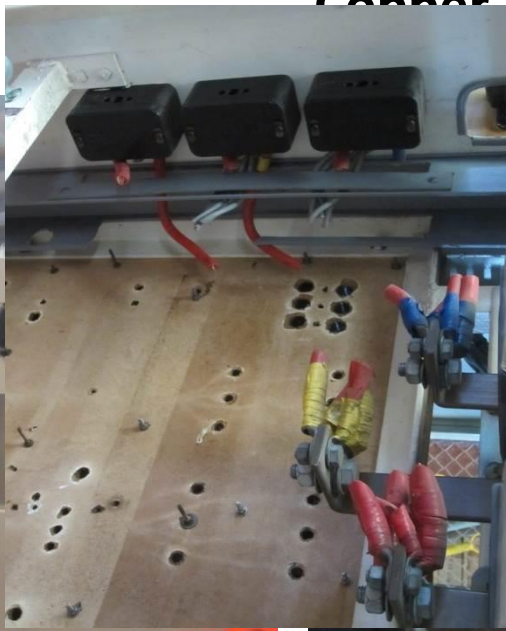
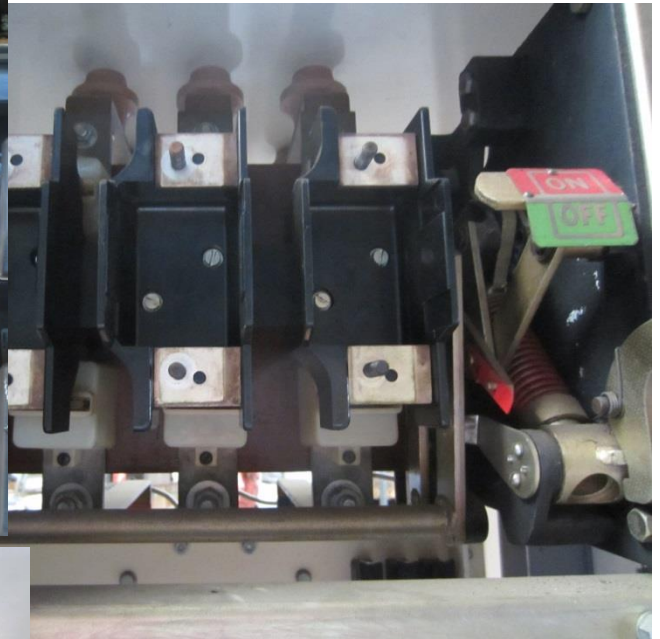
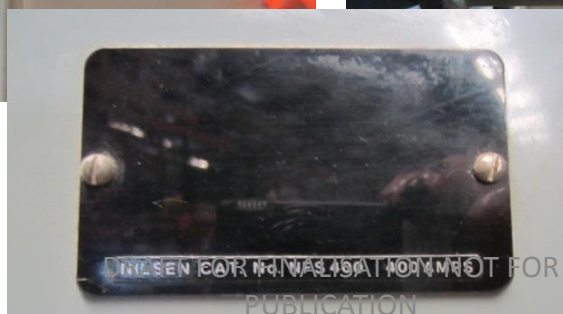
Main Panel

Copper links installed in CFS Unit

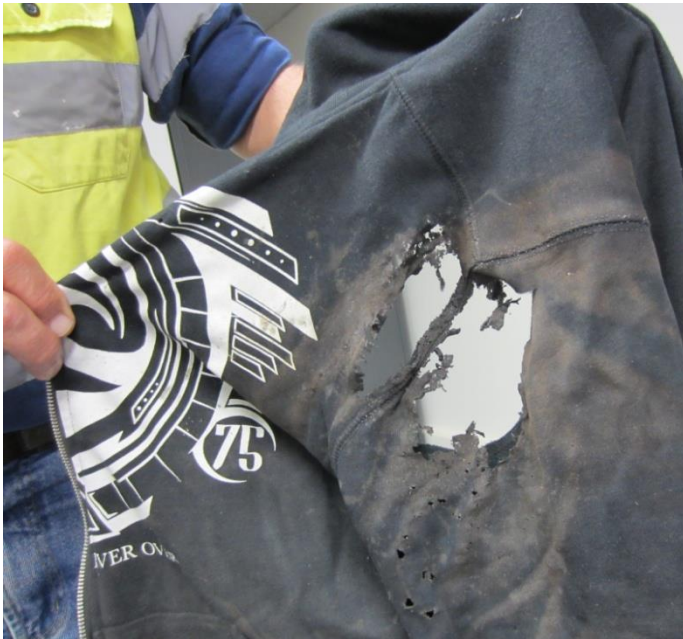
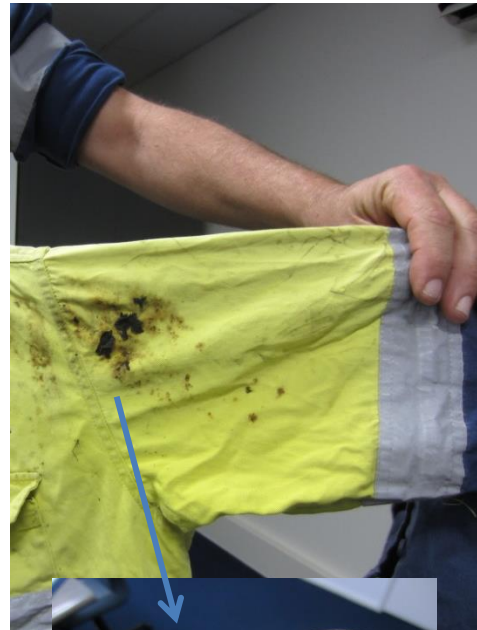
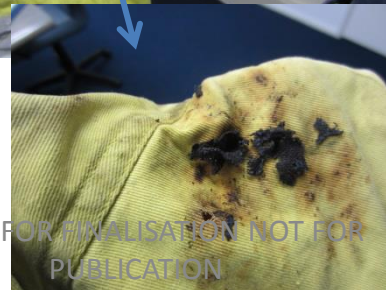
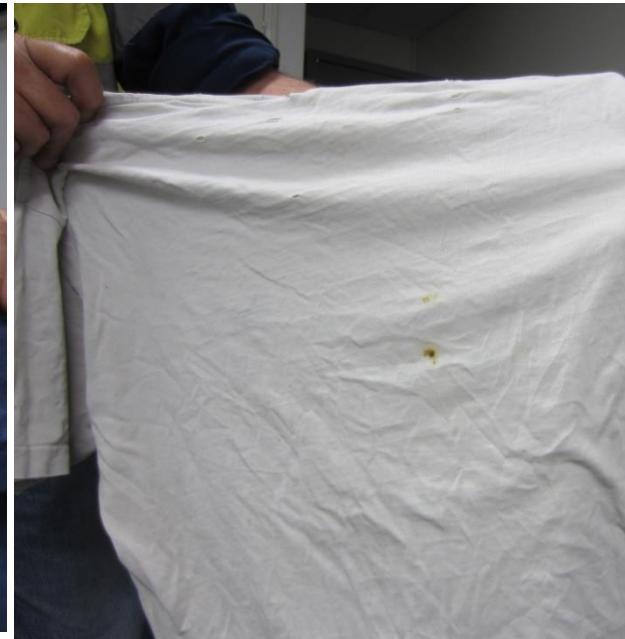
Damage to Clothing

Note: The employees were provided with safety faces shields and safety gloves by their employer but were not arc rated and not worn anyway. Clothing worn by the injured was polyester / cotton with three layers.

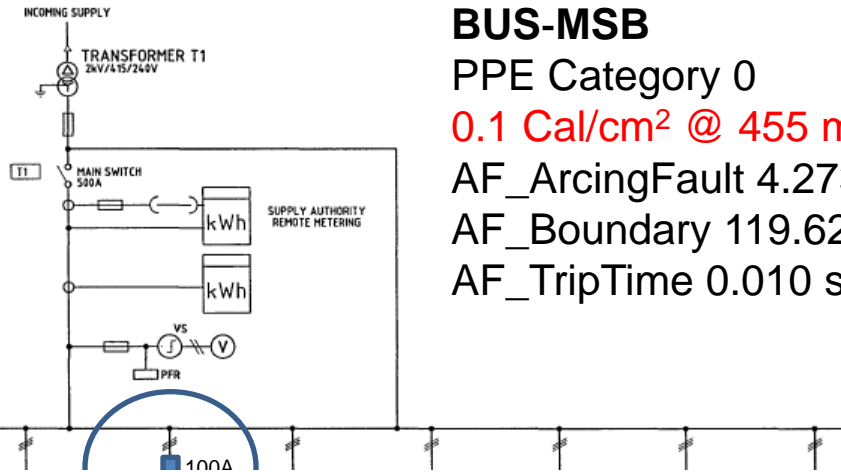
BUS-MSB

PPE Category 4

26.7 Cal/cm² @ 455 mm

AF_ArcingFault 4.273 kA

AF_Boundary 3020.11 mm

AF_TripTime 2.000 s

100A HRC Fuses Installed

BUS-MSB

PPE Category 0

0.1 Cal/cm² @ 455 mm

- Could have been 63A Fuses or CB installed
- Benefits of EL protection
