MINING
ELECTRICAL
SAFETY 2017
CONFERENCE

High Voltage Trucks

Protection and Fire Prevention

Case Study Truck Fire

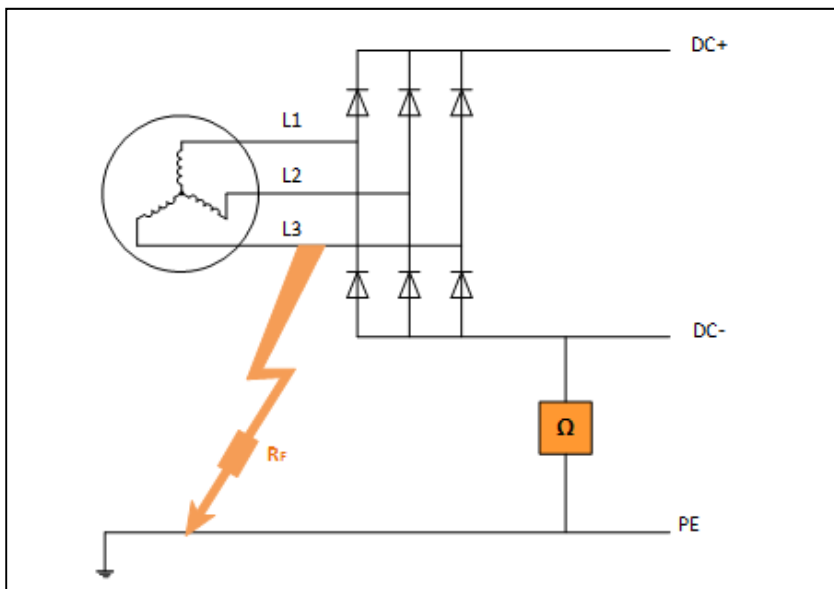
Insulation monitor settings:

- Sensing over 2 cycles was 3 cycles
- Warning from 450 k Ω , Trialling 2 M Ω
- Alarm from 100 k Ω , Trialling 1 M Ω

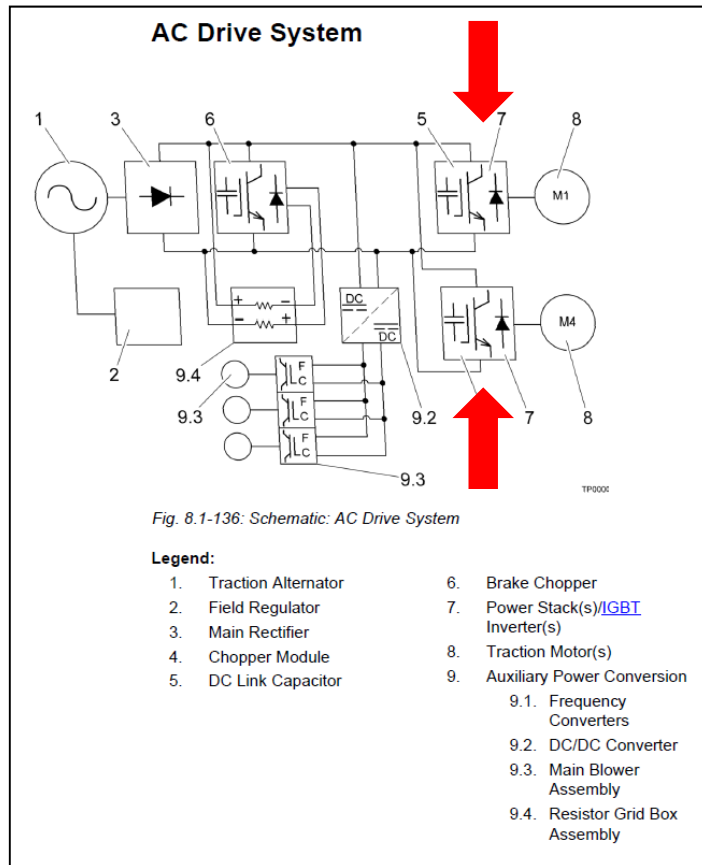
Over current detection will trigger a fault (and turn off the entire drive) if approximately 3,800 A is detected for more than 1/2 second.

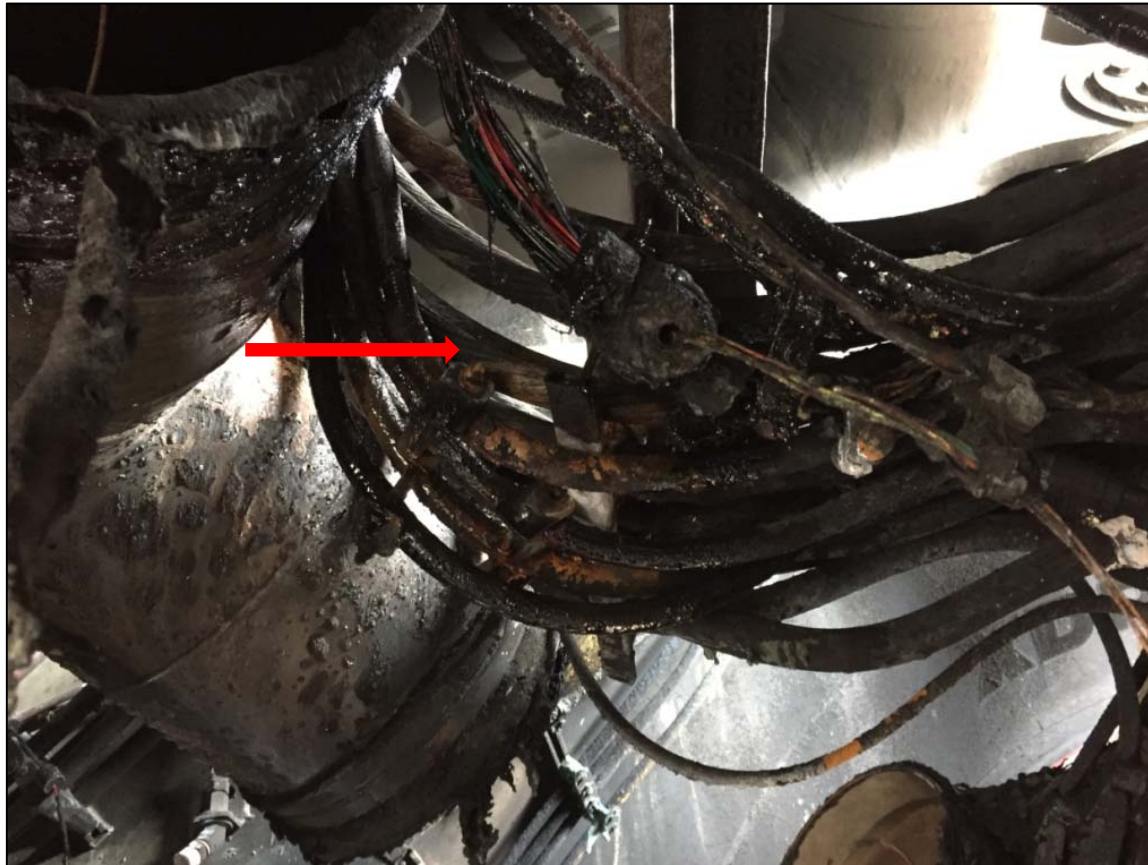
- Truck operating normally
- No alarms, truck data corrupted
- No early warning logged via the insulation monitor
- Operator didn't know the truck was on fire until notified by the dozer operator

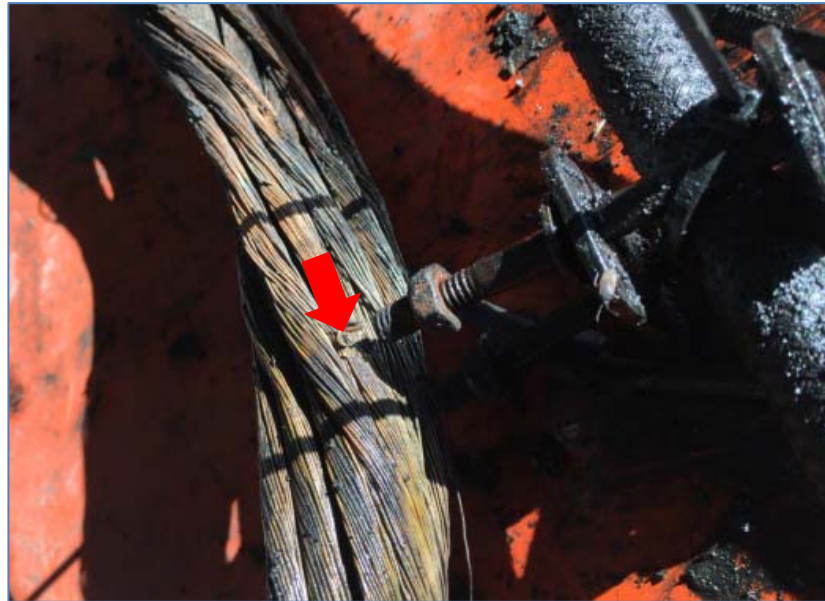
Identified cable arcing
on Motor 1 Phase U-2

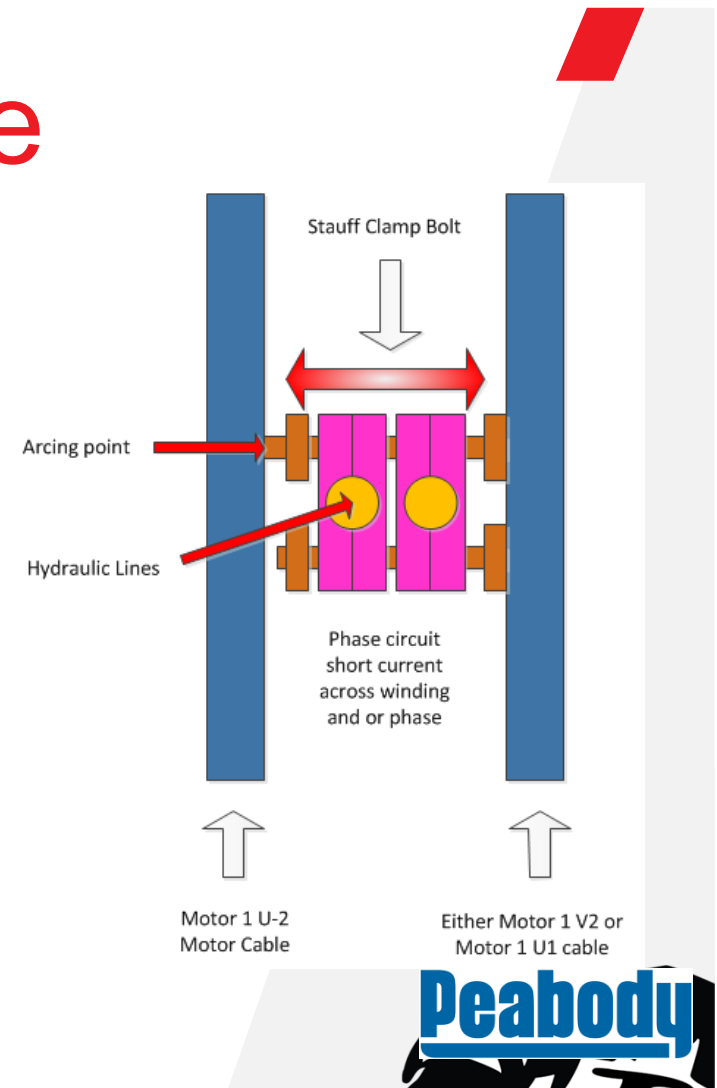
From the evidence of the arcing damage, there was current flow between Motor 1 U - 2 and most probably U -1 phase. The drive system wouldn't protect easily for this type of fault. Trip 3,800 A for 0.5 seconds.

Melting temperature for copper is 1,082C
Cable 535.3MCM (American). Temperature rating is 90C 2kV rated.

Stauff clamp supported the 3,400 PSI pressurised hydraulic park brake hose which eventually failed from heat accelerating the fire. Flash point of the oil 250 – 400C.
