Arc Flash Incident and Hazard Mitigation & Management

Robert Lewis, General Manger Operations South SunWater Limited

Incident 2 –August 2012

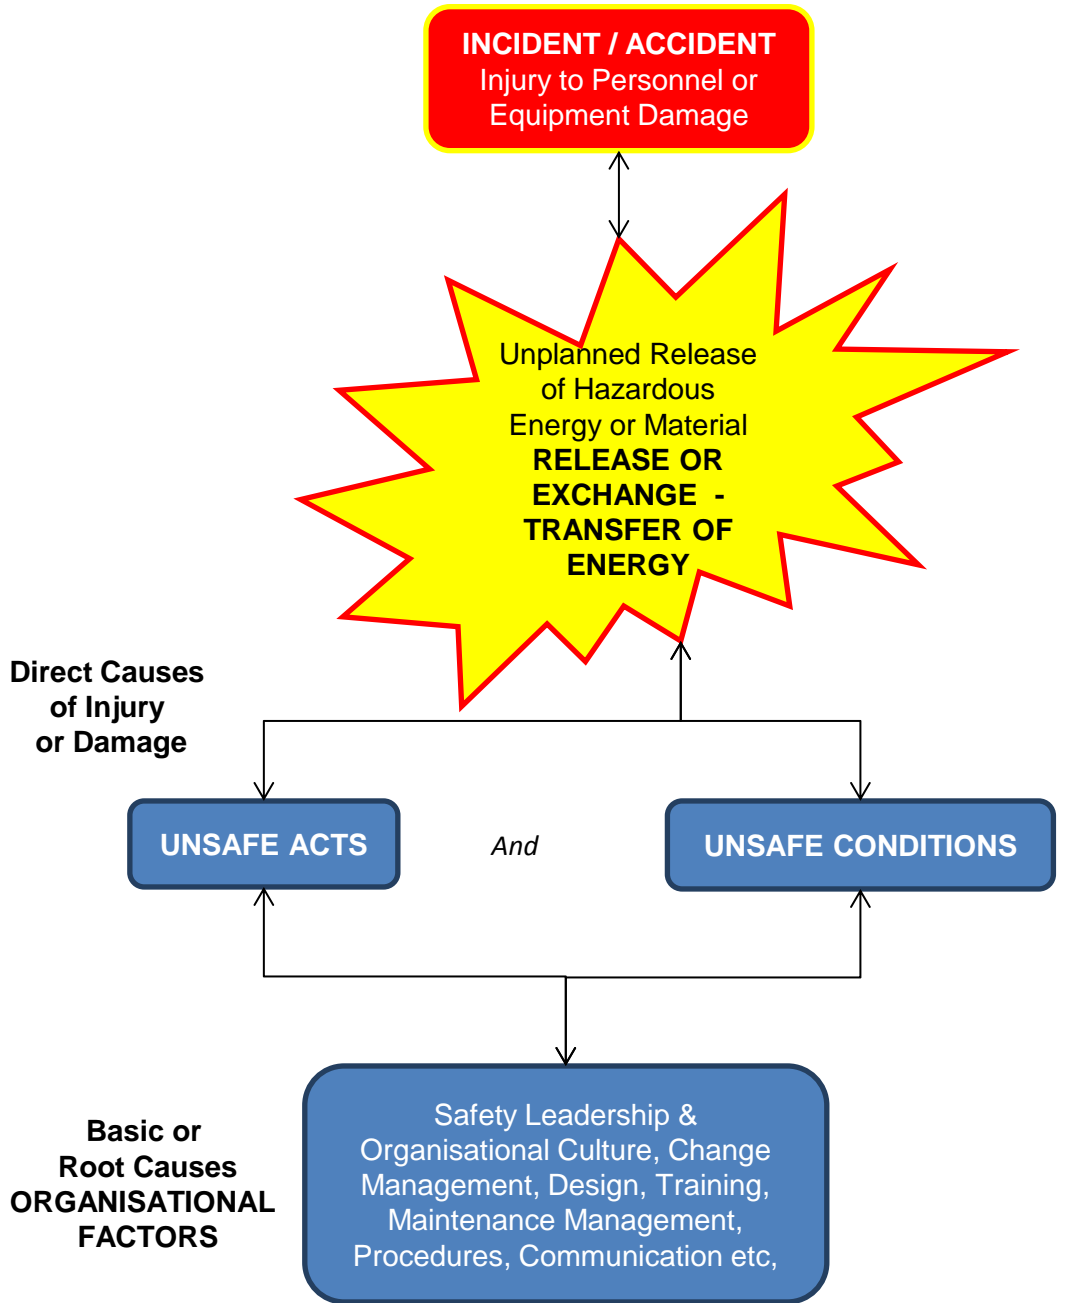
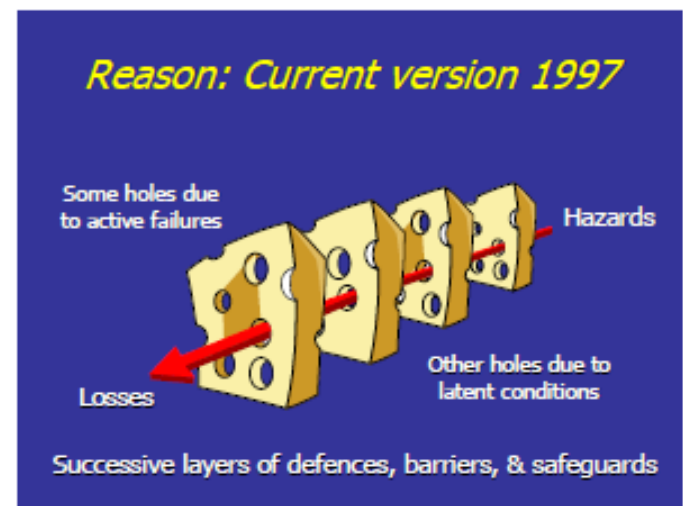
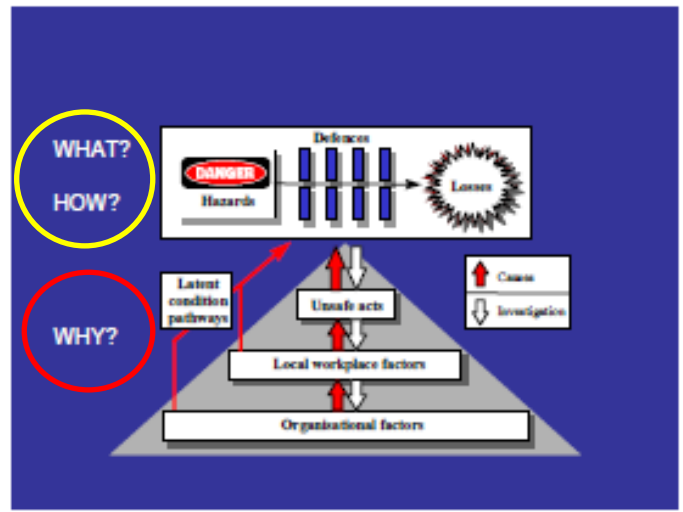
- Monday 7:59AM an accident occurred at the Theodore Pump Station.
- An electrician employee of a contractor received serious burns to his left hand and left side of his face and neck as a result of an explosion caused by electrical energy.

- An arc flash occurred a result of failure of the insulation of the switchboard.
 - Primary cause of the failure not identified.
- The accident happened on the first day of a planned shutdown of site work to replace switchboards.

- Work was generated from the planned program of switchboard replacements from the external audit.
 - This audit report recommended replacement of the main switchboard based upon condition, age and safety concerns including asbestos.

- A corrective work order for interim controls was raised in 2010 but was not closed.
- Regulator attended the accident site same day and took statements from the contractors employees and the injured person the next day.

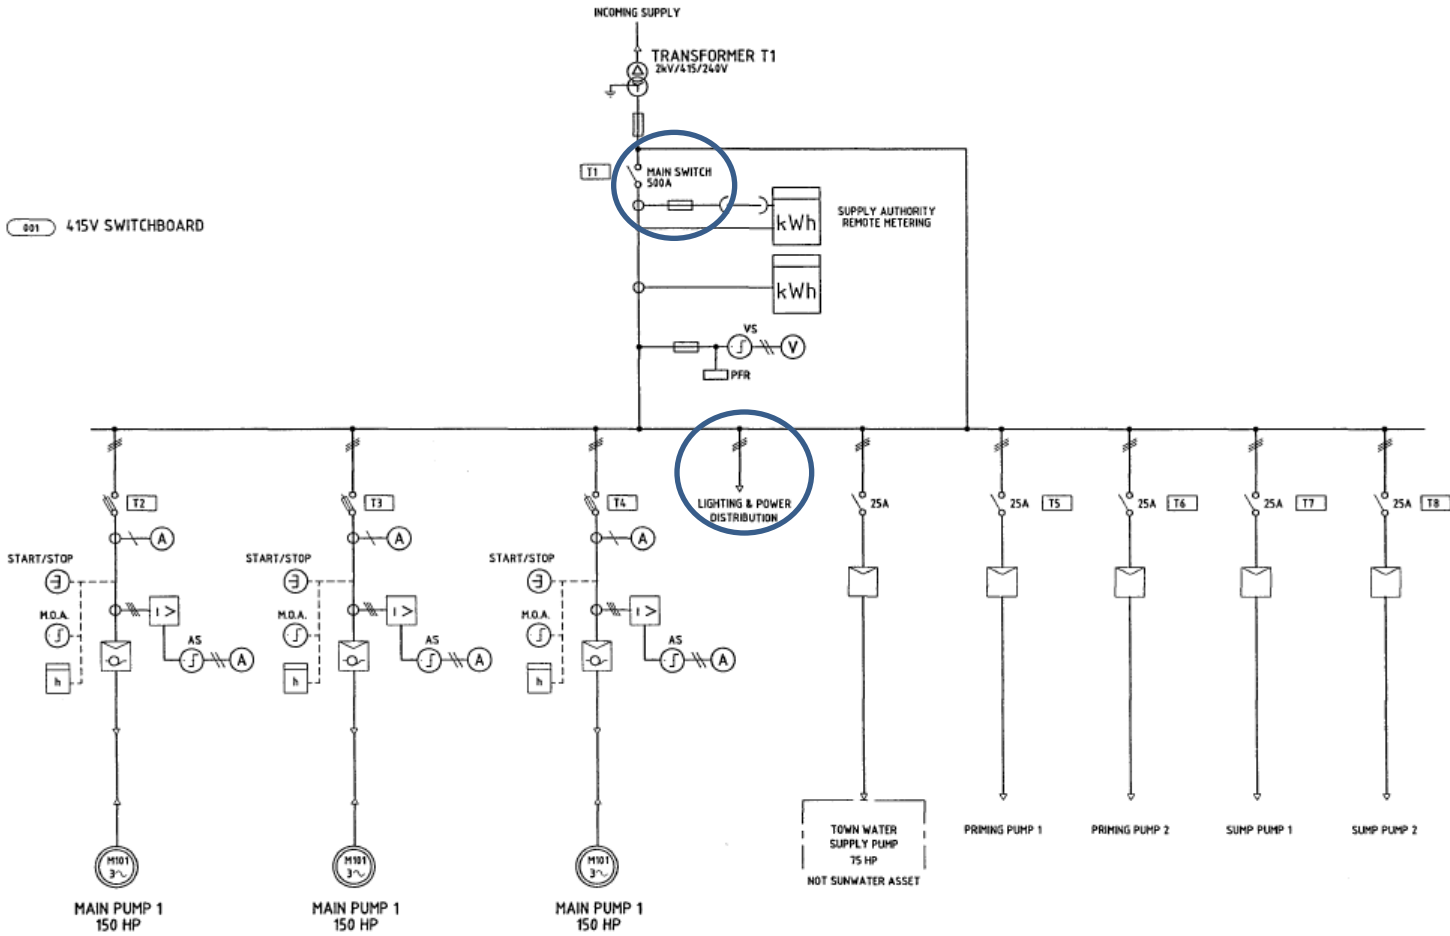
801 415V SWITCHBOARD

- Inadequate systems and standards for modifying electrical installations were applied in the past. Design verified drawings issues 1996 and 2003 showing the DB as installed.

- Adequate maintenance inspection or insulation testing was not occurring considering age of asset.
- The original design was inadequate given no point of isolation for the DB aside from the MCC Main Switch, and the inadequate electrical protection for the DB and busbars.

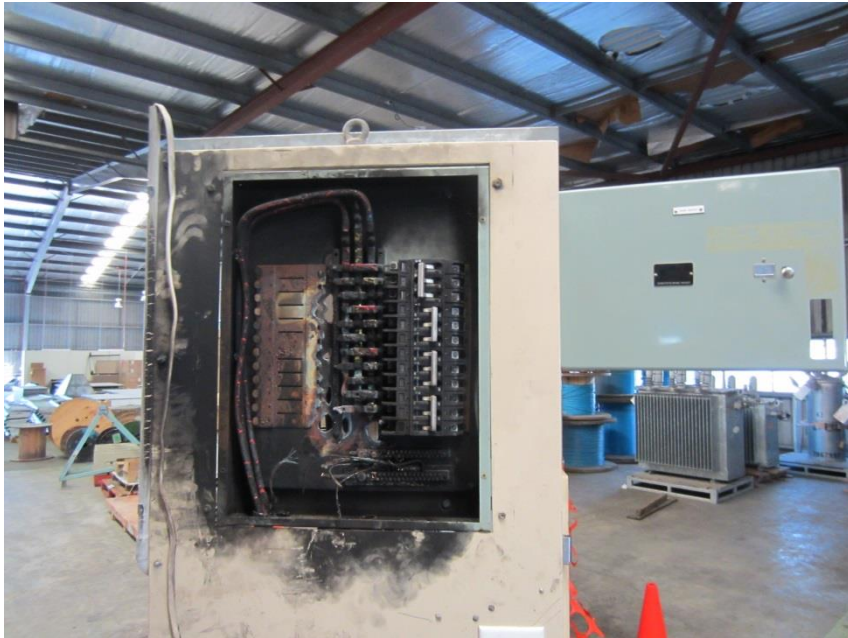
Asset & Maintenance Management

- No regular test and maintenance regime including thermography or insulation testing.
- Age of installation and insulation, particularly busbar separation – 35 years minimum.
